INSPECTION REPORT

Myddelton College

CLIMBING WALL

July 2016

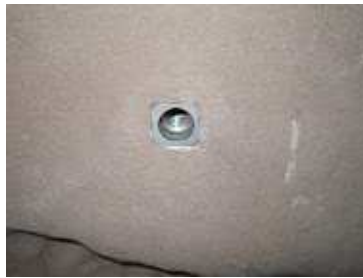
All of the fixing points inspected and checked showed no problems with either fouled threads or surface damage however, 15 on the Imprint (fibreglass) wall were found to be seized.

Also some resin in studs on the brick wall were found to be missing but had been filled in causing no issues at the time of inspection.

It is recommended that the fixing points are inspected every three months. If any are found to be loose or fouled they should be replaced when route setting takes place. Also during this process, it is advisable to lubricate the bolts to prevent seizing of the bolts due to corrosion.

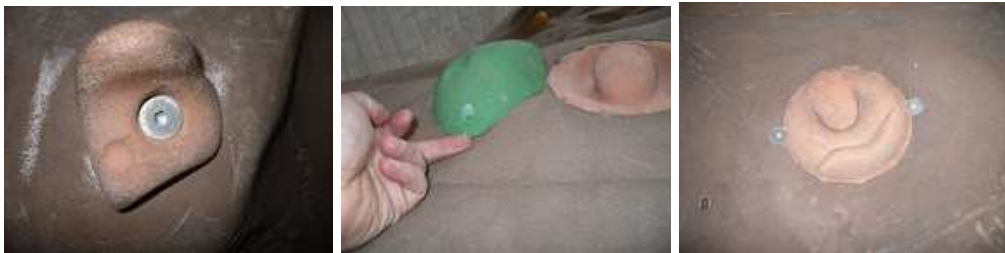
The bolt-on holds are sound and show no signs of weakness, although they were a little soiled as a result of not being used for approximately 3 years. It was noted that there were no set screws used on the wall. Approximately 25 of the bolt-on holds were found to be loose or spinning when weight was applied. Some bolt-on holds were found to have finger traps on the Imprint wall.

Any loose bolt-on holds were mechanically tightened with an impact wrench. The bolt-on holds causing finger traps on the Imprint wall were rotated to alleviate the problem.

It is recommended that the bolt-on holds be regularly checked. It is important that the supervisor of the wall regularly checks and tightens the bolt-on holds. Any loose or spinning bolt-on holds should be reported to the wall supervisor and all climbing must stop on these ropes until the holds are tightened.

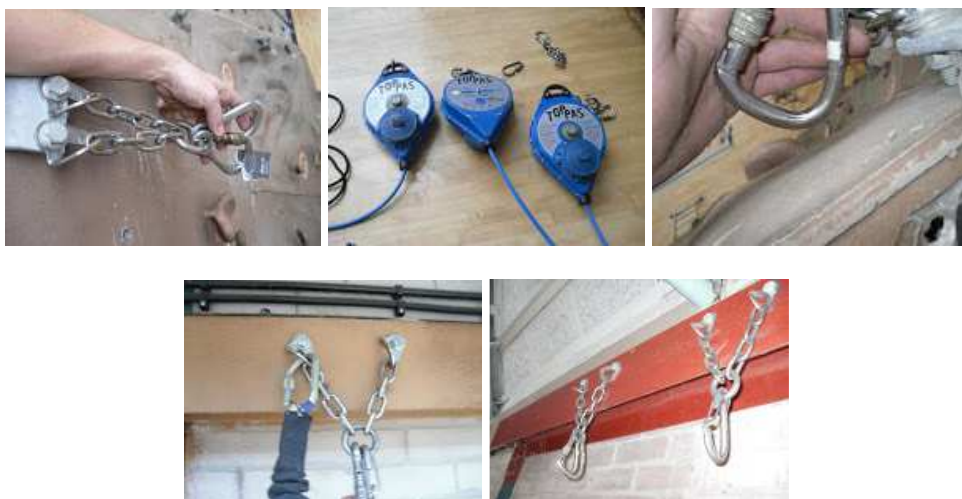
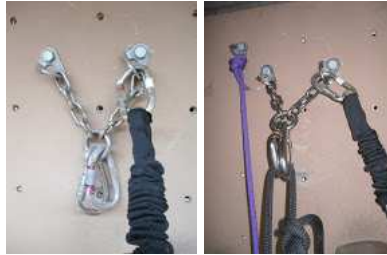
The lower off belays and intermediate protection points were found to be in good condition. However, in all areas around the climbing zones there was minor wear on the snap gate karabiners.

4 of the Y-hangs were found to be insufficient for today's climbing standards with only having a screw gate and not a second snap gate karabiner. These were taken out of action as they were not considered safe. The other 4 have both snap gate and screw gate. Although they were not fitted correctly (back to back) they were seen as safe and in good condition at the time of inspection.

On inspection it was found that an intermediate protection point, at 3m, had been removed on the articulated wall and 2 other protection points were found fitted to just T-nuts, this is considered unsafe.

The brickwork climbing wall has 3 auto belays which are the old Toppas belays. We were asked to remove these from the wall at the time of inspection. Although the client believed the removed auto belays were in date and fit for purpose, on closer inspection when removed it was found that they were out of date (see stamped dates on units).

The fixings were tightened as required. The 4 Y-hangs taken out of action were replaced with new ones- 3 on the Imprint wall and one on the articulated wall. The 2 lower hangers were removed and the hanger at 3m was re-fitted on the articulated wall.

NB. The Toppas belays should not be used until further investigation takes place to see if they are safe. It is recommended that they are serviced by an authorised dealer before being returned to use (not Entre-Prises).

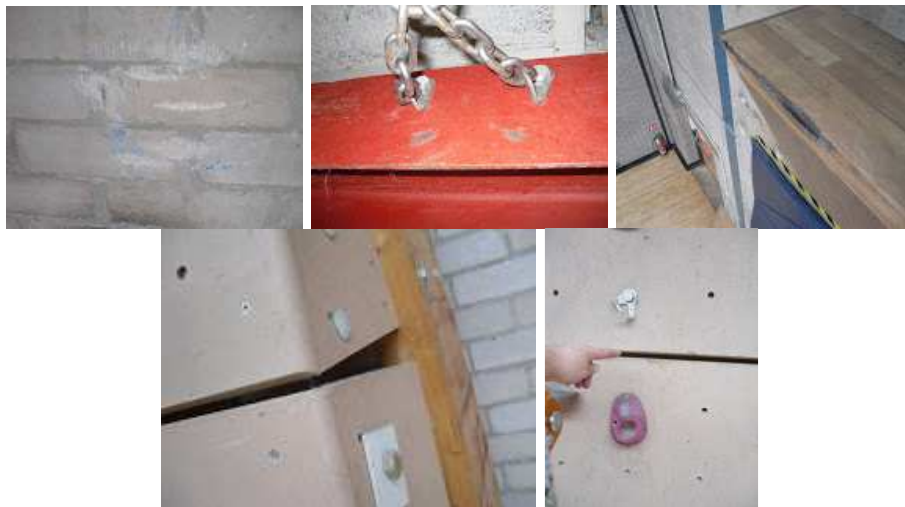
All the walls surfaces were found to be in good condition with all connection fixings secure. There was slight movement at the base of the Imprint wall to the bottom right but all bolts and fixings were secure and it was considered safe. There is slight rubbing on all the wall surfaces and there was also slight rope wear on the edge of the belay ledge. However, this has been covered with lino and was fit for purpose at the time of inspection. It was pointed out to us before the inspection that there was a gap across one of the walls, on further investigation this was found to be on the articulated wall and necessary for the articulated slab to function correctly.

Visual checks of the wall surface should be carried out regularly to check for excessive wear or damage.

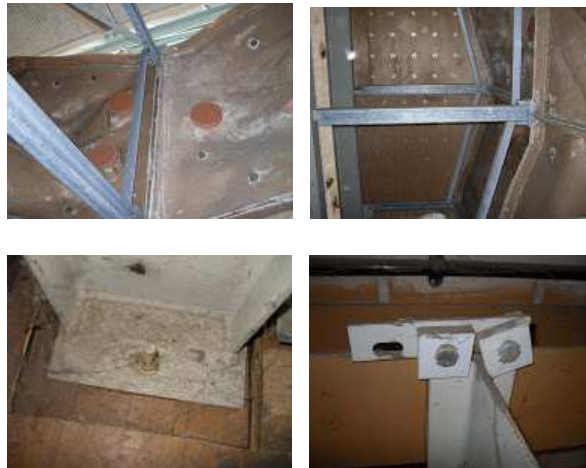
The substructure was found to be in good condition. Every bolt & connection was checked for tightness and nothing was found to be loose, fouled or missing.

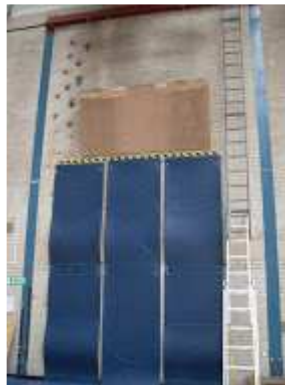
There is no safety flooring around any of the climbing surfaces, apart from a padded wall and a soft gym mat at the base of the Belay Ledge.

The safety matting was considered ok at the time of inspection at the base of the Belay Ledge.

It is recommended that safety matting is used under all climbing facilities (although this is not essential). This could be in the form of articulated matting fixed to the base of the wall and raised up when the wall is not in use. This will also deter people from climbing the wall when the wall is not in use or when there are no staff around to supervise climbing lessons.

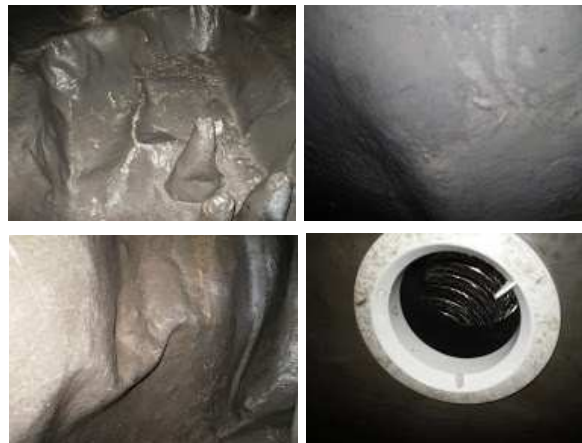
At the time of the inspection the caving system was found to be in very good condition. It was noted that there was slight wearing of the paint on the floors of the cave.

There are 4 emergency exits on the system all having doors which hold shut with magnets and a security key. The key wasn't present at the time of inspection and the doors were all open, therefore the emergency exits could not be tested.

The caving system has air conditioning, but this was not switched on at the time of inspection.

It is recommended that a security key is used to keep the doors closed and kept in a known safe place close to the exits.

We recommend that the air conditioning unit is properly checked by a qualified electrician annually.

It is also recommended that the cave is hoovered out as there are quite a few cobwebs and dust with it not being used for some years.
